Manhole Inspection Summary

Manhole # S37Y1_017MH

Insp Date: **5/1/08 12:31 PM**

Location Address: **3814 3rd St.**

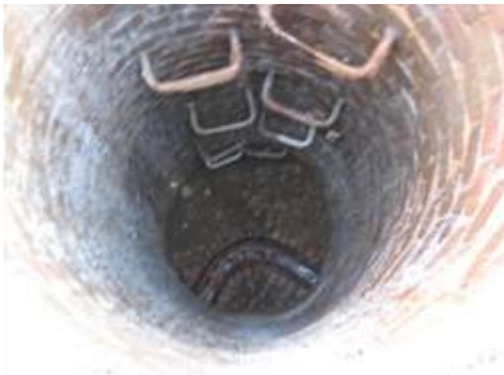
Steps Count: **8** Missing: **1** ☒ **Corroded**

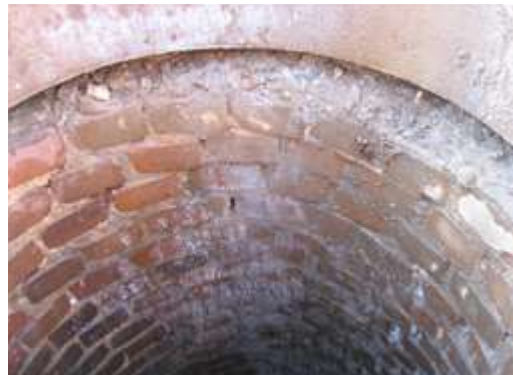
Defect 2

Condition: ☐ Sound ☐ Cracked ☐ Root Intrusion ☒ **Loose Brick** ☐ Deteriorated

Infiltration: ☐ None ☒ **Joint** ☐ Cracks ☐ Mortar ☐ Roots ☐ Wall

Chimney

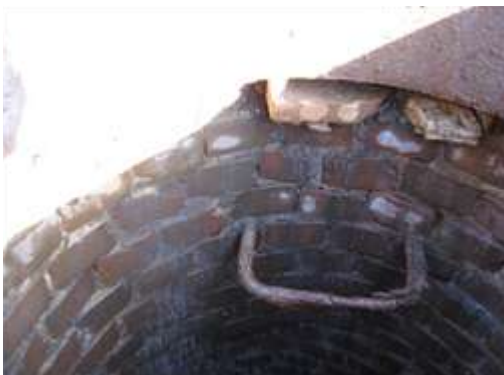
Defect 1

Chimney

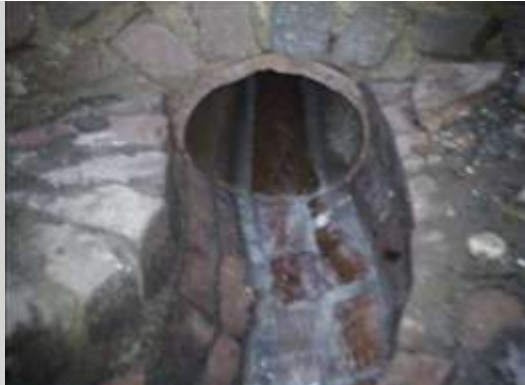
12 O'Clock Outflow

8 in. Circular Gravity Sewer
Pipe Out @ 12 O'Clock

Pipe Height: **10.8** (in.) Rod and Bar (Angled)
Pipe Material: **Clay** ☐ Pipe Lined
Invert Depth: **13.54** (ft.) Flow Characteristics: **Fast**
Deposits: ☒ None ☐ Mud ☐ Sludge ☐ Debris ☐ Grease
Silt Depth: (in.) Deposits Extent:
Infiltration: **None** Pipe Seal Cond: **Sound**

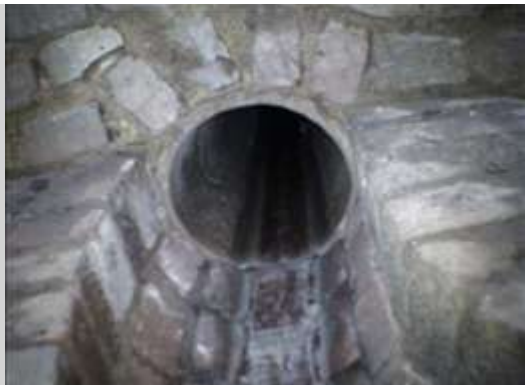
9 O'Clock Inflow

8 in. Circular Gravity Sewer
Pipe In @ 9 O'Clock

Pipe Height: **10.8** (in.) Rod and Bar (Angled)
Pipe Material: **Clay** ☐ Pipe Lined
Invert Depth: **13.02** (ft.) Flow Characteristics: **Fast**
Deposits: ☒ None ☐ Mud ☐ Sludge ☐ Debris ☐ Grease
Silt Depth: (in.) Deposits Extent:
Infiltration: **None** Pipe Seal Cond: **Sound**
